PROPERTY INSPECTION REPORT

12345 Any Street
Beautiful IN 46000

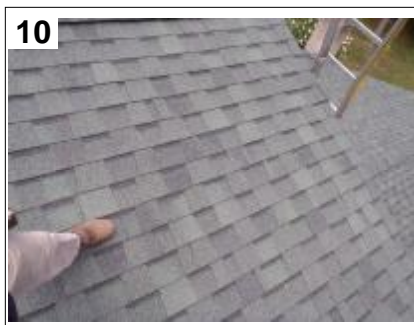
- There is staining in the attic below the roof cut out area over the garage in front of the window. - (See Photo 4)
- The upper roof decking has soft and spongy spots on the front near the North end. - (See Photo 10)
